**COMPREHENSIVE
ASBESTOS SURVEY**

***LAKE FOREST
ADMINISTRATION BUILDING***
*110 East Laurel Avenue
Lake Forest, IL 60045*

Inspection Date: October 15-17, 2008
Report Date: November 14, 2008

MEC PROJECT #: 08-09-442-INSP

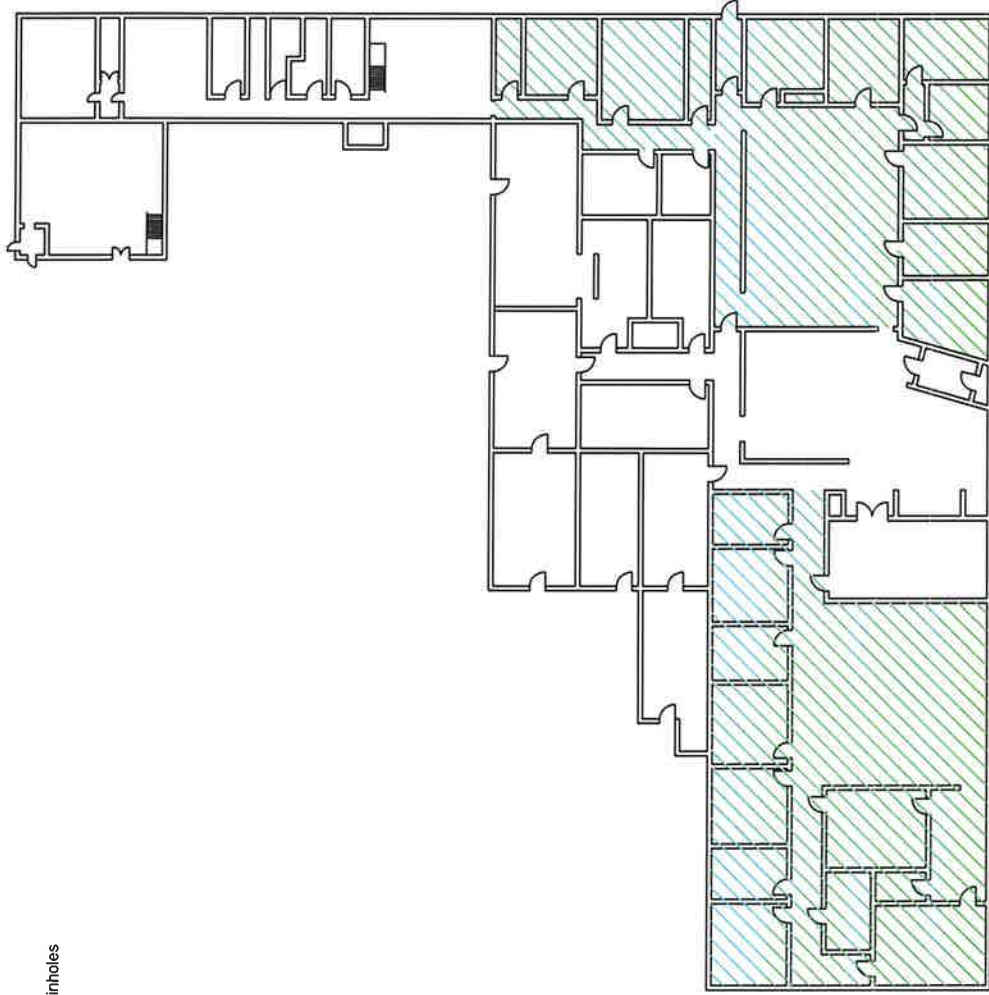
1ST FLOOR

HOMO:
DESCRIPTION: MCA
QUANTITY: 2x4 Lay-in Ceiling Tiles - White w/ Pinholes
ACM: 7,000 S.F.
COMMENTS: No

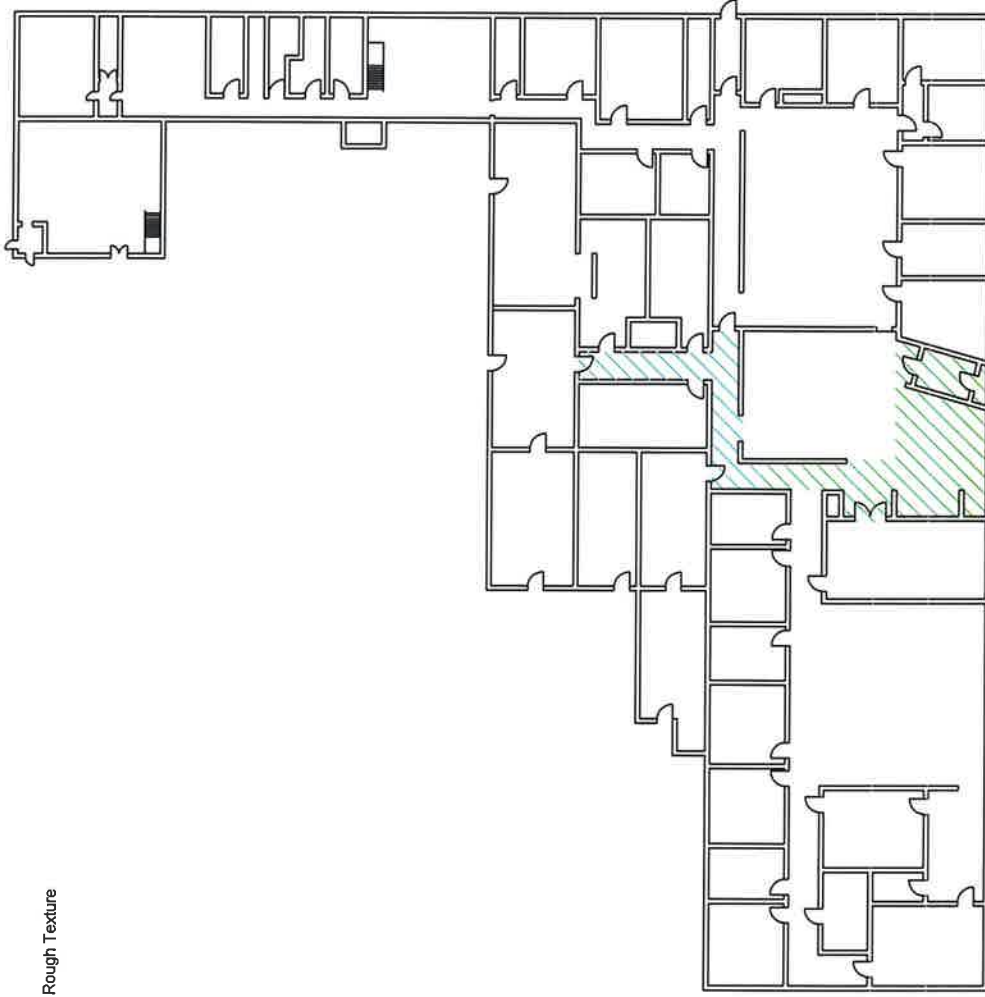
1ST FLOOR

HOMO:
DESCRIPTION: 1x1 Splined Ceiling Tiles - White w/ Rough Texture
QUANTITY: 1,185 S.F.
ACM: No
COMMENTS:
