**COMPREHENSIVE
ASBESTOS SURVEY**

CITY OF LAKE FOREST

***LAKE FOREST
MUNICIPAL FACILITY***

MEC PROJECT #: 08-09-443-INSP

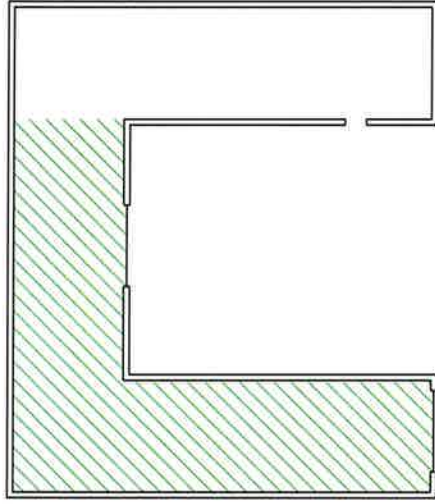
1ST FLOOR - BUILDING "A"

MMA
 Plaster Board
 800 S.F.
 No
